PANAMA CANAL COMMISSION

GEOLOGICAL FIELD LOG

BORING CMRB-1A

PROJECT: COROZAL MIRAFLORES ROAD AND BRIDGE

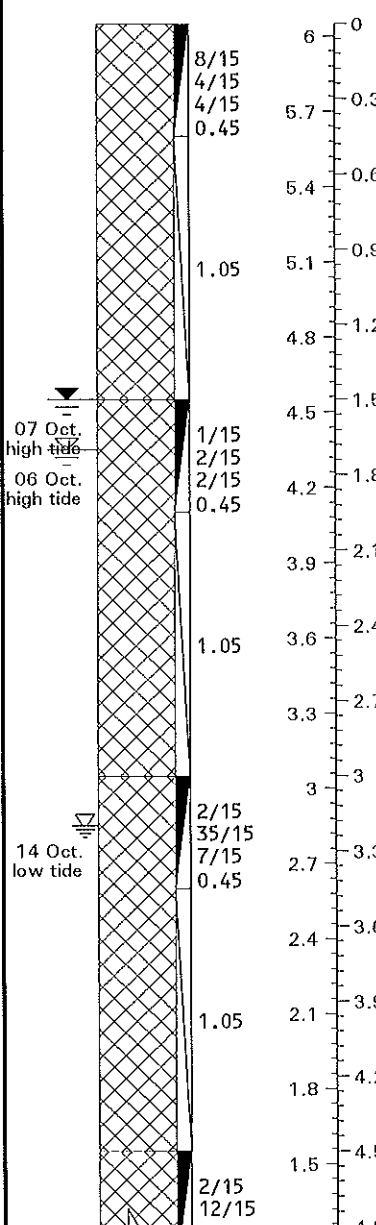
PAGE 1 OF 4

<p>07 Oct. high tide</p> <p>06 Oct. high tide</p> <p>14 Oct. low tide</p>	8/15	0	FILL, OC-2, medium-low consistency, weak, low water content, low plasticity, low dry strength, consists of clay, sand, and silt mixed with angular to sub-angular basaltic and andesitic fragments up to 3.5cm in diameter, contains some roots in upper 18cm and is more clayey, lower 27cm contains abundant iron oxides. Color: upper 18cm are brown, red-brown, and black, lower 27cm are ochre, orange, and red-brown.		SPT #1	100%	-
	4/15	0.3					
	4/15	0.6

0.45	0.9					
	1.05	1.2	FILL, OC-2, medium-low consistency, weak, moderate water content, moderate plasticity, high dry strength, consists of clay, coarse-grained sand, abundant small pebbles, and silt, mixed with sub-angular to angular basaltic and andesitic fragments up to 3.5cm in diameter. Color: mottled medium yellow and red-brown, brownish gray, and green.		SPT #2	40%	-

1.5					
	1/15	1.8					
	2/15	2.1					
	0.45	2.4	FILL, OC-1 to OC-2, low to medium-low consistency, weak, moderate to high water content, high plasticity, sticky, moderate to high dry strength, consists of clay, silt and sand, and abundant small pebbles, with one hard, basaltic or andesitic fragment 3cm in diameter. Color: medium gray-brown mottled with red and blue-gray, and scattered ochre and green.		SPT #3	42%	-

2.7					
	2/15	3.0					
	35/15	3.3					
	7/15	3.6	FILL, OC-1, low consistency, weak, high water content, high plasticity, sticky, high dry strength, consists of clay,		SPT #4

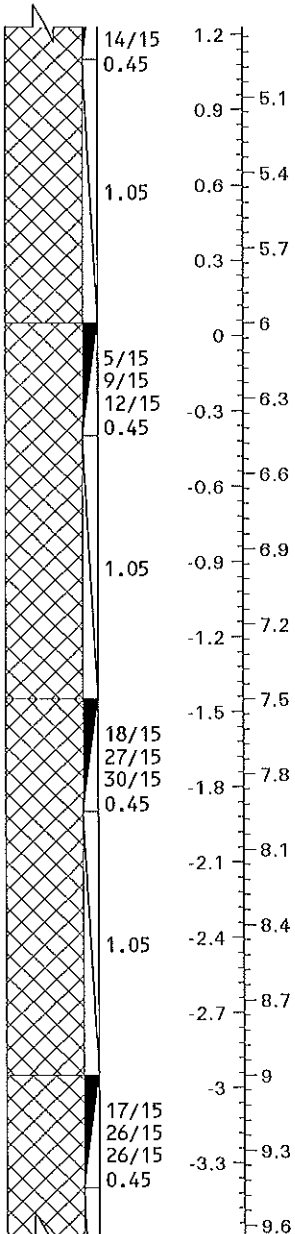
PAGE 2 OF 4

14/15	1.2	silt, and sand mixed with abundant, small, hard andesitic and basaltic pebbles and scattered few sub-angular and angular fragments of varying composition up to 3cm in diameter. Color: medium gray-brown mottled with red and green-gray.		Cleaned with 3 1/2 in. tricone rotary bit and water. 4.5m of 4" casing installed.	22%	-

0.45	5.1					
	1.05	5.4					
		5.7					
		6					
	5/15	0	FILL, OC-2 to OC-3, medium-low to medium-high consistency, weak, low water content, variable plasticity, low dry strength, consists of clay, sand and silt, contains clasts of less altered tuff and scattered iron oxides. Color: pockets of mottled green-gray, red-brown, yellow, and ochre.	SPT #5	Cleaned with 3 1/2 in. tricone rotary bit and water. 6.0m of 4" casing installed.	100%	-
	9/15	6.3					
	12/15	-0.3

0.45	6.6					
		6.9					
	18/15	-1.5	FILL, OC-2 to RH-5, medium-low consistency to very hard rock, weak, low to moderate water content, low plasticity, low dry strength, consists of abundant hard, angular gravel up to 1.5cm in diameter, weakly cemented by pockets of clay and sand, material is friable, and contains scattered iron oxides. Color: black with pockets of ochre, cream, and red-brown.	SPT #6	Cleaned with 3 1/2 in. tricone rotary bit and water. At depth 7.20m water color became light creamy gray.	100%	-
	27/15	7.8					
	30/15	-1.8

0.45	8.1					
		8.4					
	17/15	-3	FILL, same as in SPT #6, OC-2 to RH-5, medium-low consistency to very hard rock, weak, low to moderate water content, low plasticity, low dry strength, consists of abundant hard, angular gravel up to 1.5cm in diameter weakly cemented by pockets of clay and	SPT #7	Cleaned with 3 1/2 in. tricone rotary	91%	-
	26/15	9.3

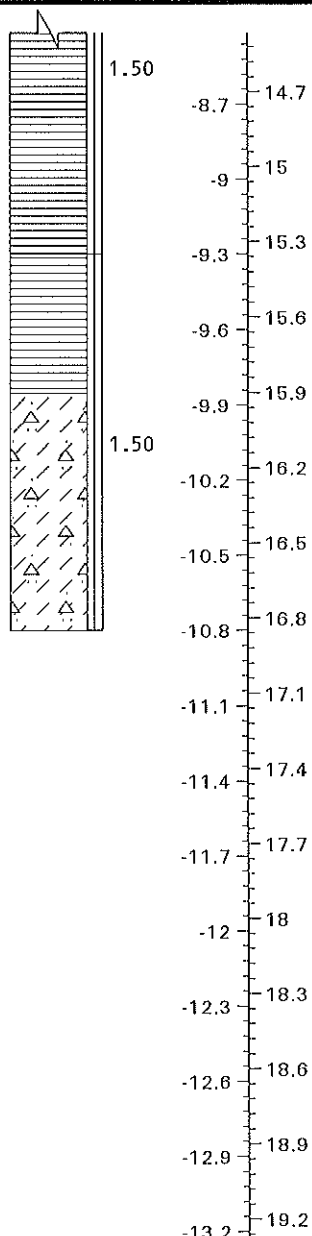
PAGE 4 OF 4

1.50	14.7	mottled with scattered white.				
	-8.7	15	TOP OF FAIRLY SOUND ROCK, CLAYSHALE, RH-2, medium-soft rock, weak, very close jointing, joints are open, sub-horizontal, sub-vertical, some joints coated with iron oxides and manganese stains, one joint is slickensided, massive bedding, very fine-grained, water-laid, contains abundant fine-grained sand with a grey to black metallic lustre, possibly magnetite, altered to clay minerals. Color: weak to dusky red.		Drilled slowly, as above.	100%	0.0%
	-9.3	15.3	CLAYSHALE, as above, but RH-1 to RH-2, material was removed from barrel in disturbed condition, as clay with clayshale intact in center.				
	-9.6	15.6	TUFF, AGGLOMERATIC, RH-2 to RH-3, as in CMRB-1, medium-soft to medium-hard rock, weak to moderate strength, close jointing, joints are open, horizontal to sub-horizontal, massive bedding, consists of sub-angular to angular fragments of varying composition in a fine-grained, sandy, tuffaceous matrix altered to clay minerals, contains elongated and sub-rounded clasts of tuff up to 2cm in length, some clasts are altered to clay minerals, some are less altered and harder, contains fine-grained sand with a black metallic lustre, possibly magnetite. Color: light purplish grey mottled with dusky red.			93%	51%
