PANAMA CANAL AUTHORITY

GEOLOGICAL FIELD LOG

BORING CCMT-9

PROJECT: CONTROL CENTER - MARINE TRAFFIC

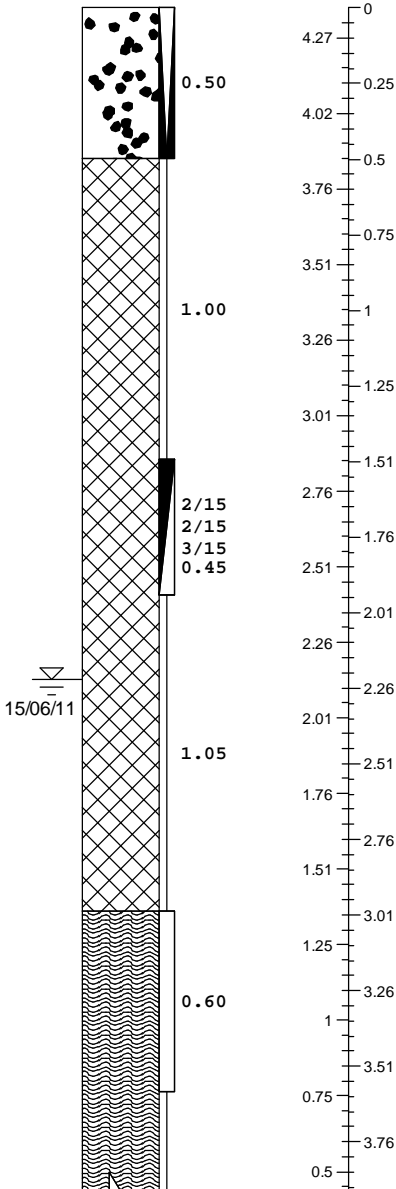
PAGE 1 OF 5

0	0.00 m ASPHALT AND CONCRETE.		Drilled with 3 5/8" tricone rotary bit and water, no attempt to recover core was made.

4.27	0.25						
		4.02	0.5	0.50 m FILL, OC-1 to RH-4, low consistency to hard rock, low to high plasticity, low to high dry strength, moderate water content, consists of clay, silt, sand, angular rock fragments up to 60 mm thick, vegetation roots, organic material. Color: brownish mottle with dark gray and greenish.		Pushed dry with HQ single tube. H. P. 0 PSI.		0%	-

3.26	1.25	C.R.=36%					
		3.01	1.51	1.50 m FILL, OC-1 to RH-4, low consistency to hard rock, low to high plasticity, low to high dry strength, moderate water content, consists of clay, silt, sand, angular rock fragments up to 30 mm thick, organic material. Color: brown, gray and black.		From 1.50 m to 1.95 m. SPT #1 - N=5		78%	-

1.51	3.01	3.00 m PACIFIC MUCK, OC-1 to OC-3, low to medium high consistency, high plasticity, high dry strength, moderate water content, consists of clay, silt, sand, abundant organic material, vegetation roots, decomposed wood, fossiliferous debris. Color: Black, brown and greenish.

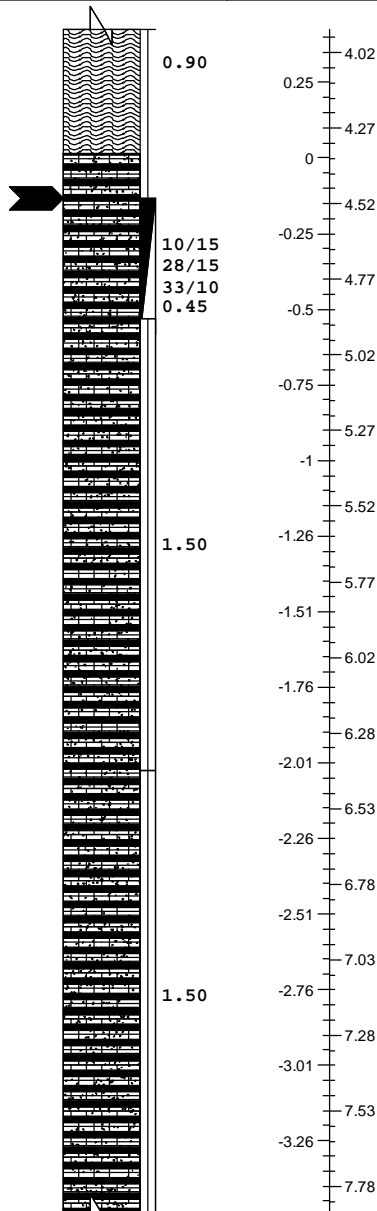
PAGE 2 OF 5

0.90	4.02	<p>4.35 m - TOP OF LA BOCA FORMATION AND TOP OF WEATHERED ROCK</p> <p>SANDSTONE, Calcareous, OC-5 to RH-3, high consistency to medium hard rock, weak to moderate strength, weathered, very close jointing, joints are planar, rough, through 30° dipping beds, parts through bedding, medium grained, water-laid, contains carbonaceous and fossiliferous debris, quartz crystals, scattered sub angular to sub rounded rock fragments up to 2 mm in diameter, weathering decreases and hardness increases with depth. Color: greenish gray.</p> <p>C.R.=54%</p> <p>6.40 m - 7.90 m</p> <p>Very close jointing, joints are planar, rough, dipping 30°, some are filled with oxides and others are unfilled.</p>		<p>From 4.50 m to 4.90 m: SPT #2 - N=61.</p> <p>4.90 m to 11.90 m: Drilled with HQ double tube, diamond bit and water. Core recovered in poor condition and in poor, fragmentary condition, is highly weathered, iron stained and oxidized.</p> <p>Drilled as above.</p>		100%	-

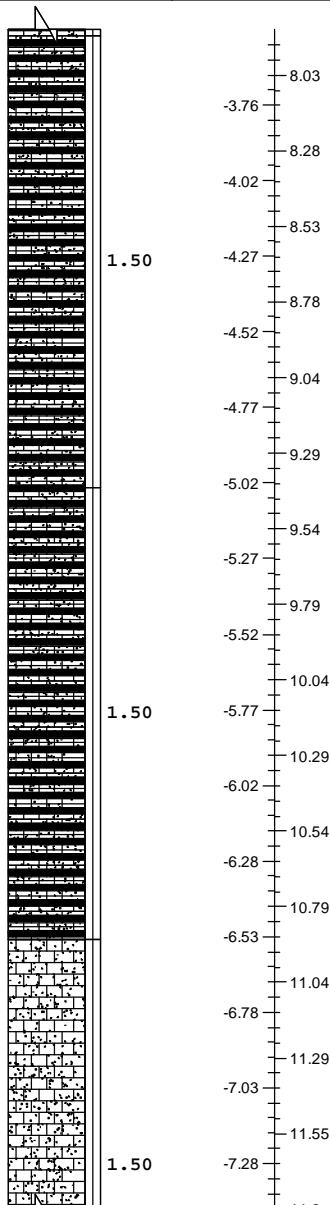
PAGE 3 OF 5

8.03			Drilled as above, core recovered in poor, fragmentary condition.		37%	0%
		-3.76

8.28						
		-4.02						
	1.50	8.53						
		-4.27						
		8.78						
		-4.52						
		9.04						
		-4.77						
			9.29	9.20 m to 9.70 m: Very close jointing, joints are planar, rough, dipping 30°, unfilled.			57%	0%
			-5.02

9.54					
			-5.27					
			9.79	9.70 m to 10.20 m: Possible fault gouge zone.				
			-5.52					
	1.50	10.04			10.20-10.55m Vertical joint, planar, rough, unfilled.			
			-5.77

10.29					
			-6.02					
		10.54						
		-6.28						
		10.79						
		-6.53	10.90 m -TOP OF SOUND ROCK		Drilled as above.		87%	0%
		11.04	SANDSTONE, Calcareous, RH-3, medium hard rock, moderate strength, wide jointing, joints are planar, rough, some are unfilled and some are filled with oxides, massive, with abundant thin sub horizontal dark grey beds and seams which seem carbonaceous, fine to medium grained, contains quartz and calcite crystals, carbonaceous and fossiliferous debris, scattered sub angular to sub					
		-6.78

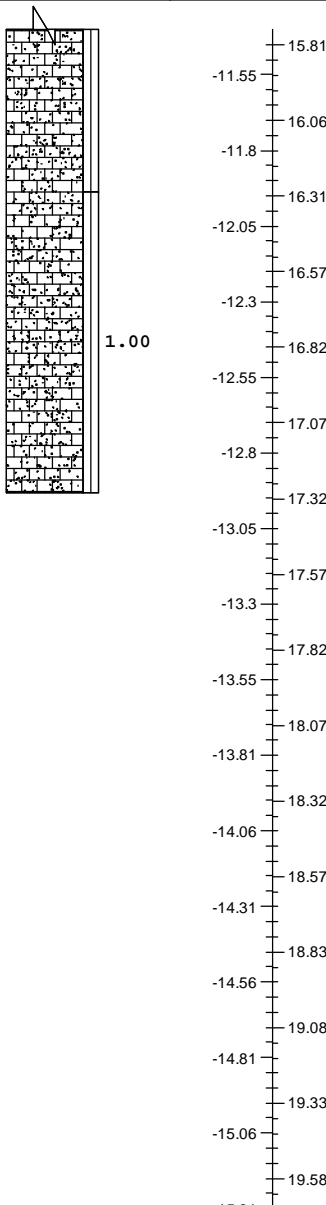
PAGE 5 OF 5

15.81			15.90 m Lost water return.			
		-11.55					80%	80%

16.06						
		-11.8			Drilled as above.			
		16.31						
		-12.05						
		16.57						
		-12.3						
		16.82						
		-12.55						
		17.07						
		-12.8						
		17.32					80%	80%
		-13.05
