**PANAMA CANAL AUTHORITY**  
**DEPARTMENT OF ENGINEERING AND PROGRAMS MANAGEMENT**  
**GEOLOGICAL FIELD LOG**

**BORING CCMT-6**

**PROJECT: CONTROL CENTER - MARINE TRAFFIC**

**LOCATION:** BALBOA REACH - EAST BANK - WEST COROZAL

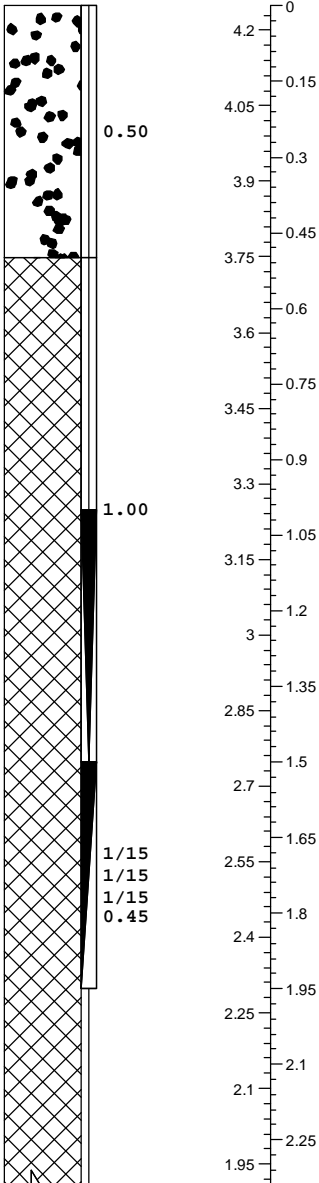
PAGE 1 OF 6

0	0.00 m ASPHALT AND CONCRETE.		Drilled with HW single tube, diamond shoe and water.

0.15						
		0.3						
		0.45						
		0.6	0.50 m FILL, OC-1 to RH-5, low consistency to very hard rock, high to low plasticity, moderate water content, consists of clay, silt, sand, angular rock fragments up to 60 mm in length and organic material. Color: brown mottled with dark gray and cream.		Pushed and drilled dry with HQ single tube.		40%	-

1.35						
		1.5						
		1.65						
		1.8	1.50 m FILL, OC-1, very low to low consistency, high to low plasticity, high to low dry strength, moderate water content, consists of clay, silt, sand, very hard, RH-5, angular rock fragments up to 20 mm in diameter, organic material. Color: brown mottled with dark gray and cream.		From 1.50 m to 1.95 m: SPT #1 - N=2		35%	-

2.55						
		2.7						
		2.85						
		3			1.95 m - 2.90 m Pushed dry with HQ single tube. H.P. 0 PSI.			
		3.15						
		3.3						
		3.45

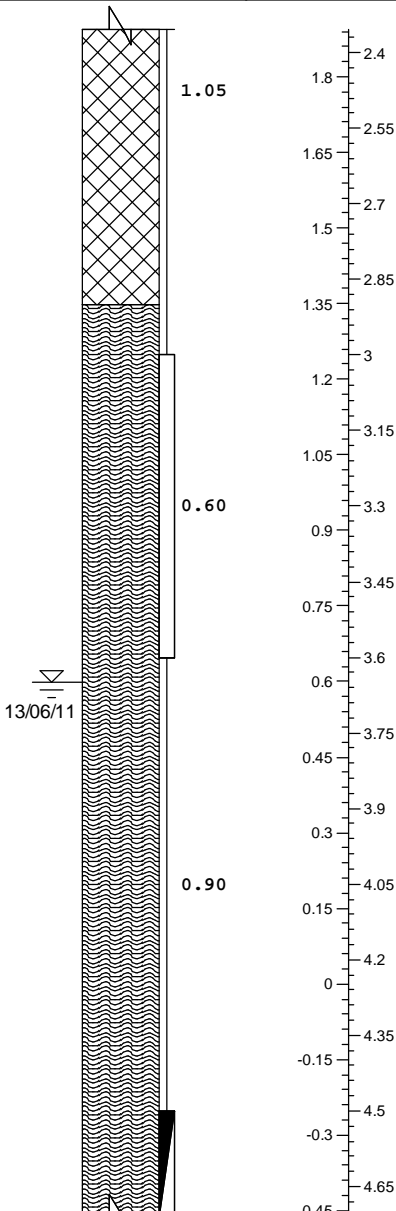
PAGE 2 OF 6

<p>13/06/11</p>	1.05	2.4	<p>2.90 m</p> <p>PACIFIC MUCK, OC-1, very low consistency, high plasticity, high dry strength, moderate water content, consists of clay, silt, sand, vegetation roots, semi-decayed wood fragments, organic material, fossiliferous shell debris. Color: black and dark gray.</p> <p>C.R.=93%</p> <p>3.00 m</p> <p>PACIFIC MUCK, as above.</p> <p>C.R.=68%</p>		Undisturbed thin wall Shelby tube. H.P. 0 PSI		81%	-
	0.60	3					68%	-
	0.90	3.3						
		3.6	<p>4.50 m</p> <p>PACIFIC MUCK, as above.</p> <p>C.R.=100%</p>		From 4.50 m to 4.95 m: SPT #2 - N=1

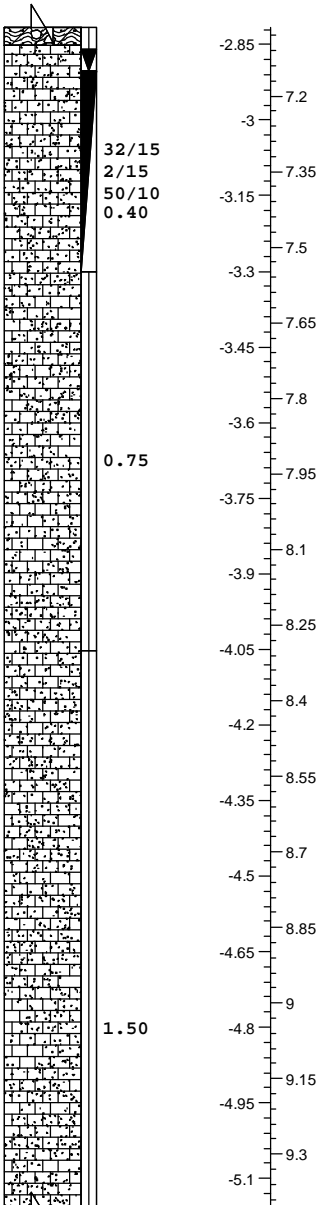
PAGE 4 OF 6

-2.85	7.10 m - TOP OF LA BOCA FM AND TOP OF SOUND ROCK		From 7.15 m to 7.55 m: SPT #3 - N=52.		100%	-
		-3.00	SANDSTONE, Calcareous, RH-3, medium hard rock, moderate strength, moderate to wide jointing, joints are planar, rough, unfilled, massive, locally exhibits 30° thin bedding, fine to medium grained, water-laid, contains quartz and calcite crystals, carbonaceous and fossiliferous debris, scattered sub-rounded rock fragments up to 2 mm in diameter. Color: light gray.		Drilled with HQ double tube, diamond bit and water.		87%	-
		-3.15	C.R.=93% RQD=79% 7.15 m SANDSTONE, Calcareous, as above.					
		-3.30			Drilled with HQ double tube, diamond bit and water.		100%	100%

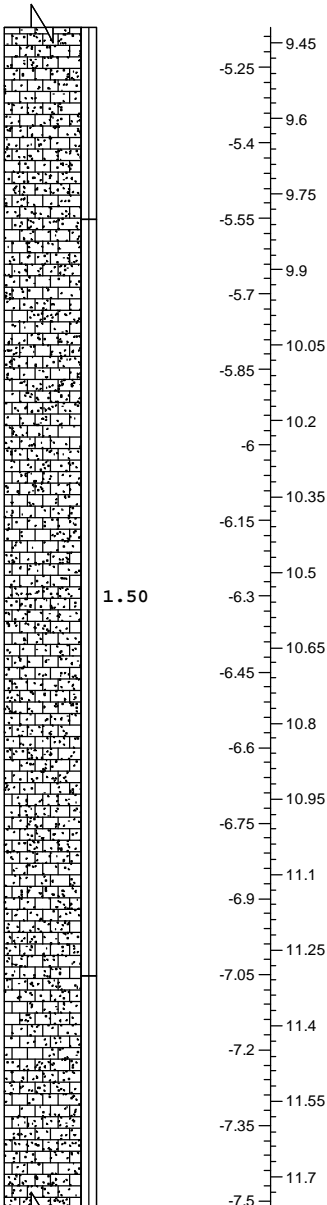
PAGE 5 OF 6

9.45	<p>From 9.80 m to 10.25 m: SANDSTONE, Calcareous, very close jointing, joints are planar, rough, un- filled, exhibits 30° bedding, parts through bedding, material is clayey, weathered, iron stained and oxidized.</p>		<p>Drilled with HQ double tube, diamond bit and water.</p>		95%	100%
		-5.25						
		-9.6						
		-5.4						
		-9.75						
		-5.55						
		-9.9						
		-5.7						
		-10.05						
		-5.85						
		-10.2						
		-6						
		-10.35						
		-6.15						
		-10.5						
		-6.3						
		-10.65						
		-6.45						
		-10.8						
		-6.6						
		-10.95						
		-6.75						
		-11.1						
		-6.9						
		-11.25						
		-7.05						
		-11.4						
		-7.2						
		-11.55						
		-7.35						
		-11.7						
		-7.5						
			<p>10.25 m Sandstone, Calcareous, as from depth 7.15 m to 9.80 m.</p>		<p>Drilled with HQ double tube, diamond bit and water.</p>		87%	60%
