# PANAMA CANAL AUTHORITY

### GEOLOGICAL FIELD LOG

#### BORING CCMT-8

**PROJECT: CONTROL CENTER - MARINE TRAFFIC**

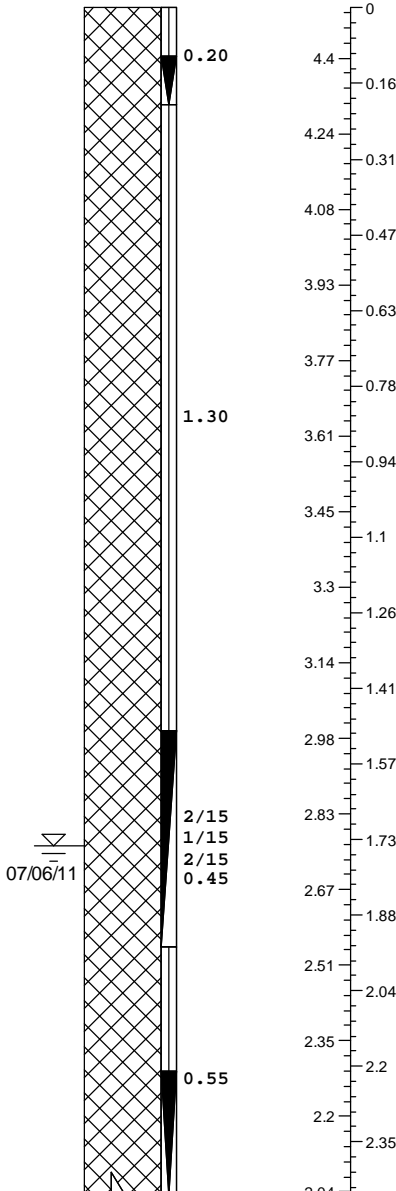
SOIL SYMBOLS, SAMPLERS, FIELD TEST DATA AND CORE RUN	ELEVATION	DEPTH	DESCRIPTION OF MATERIAL	DISCONTINUITY	DRILLING CHARACTERISTICS	qu MPa	CORE RECOV (%)	RQD (%)
	(meters)

0.20	0.00	0.00 m FILL, OC-1 to RH-4, low consistency to hard rock, low to high strength, low to high plasticity, moderate to high water content, consists of clay, silt, sand, concrete, angular rock fragments up to 100 mm long, vegetation roots, organic material. Color: brown, gray and black.		Pushed and drilled dry with HQ single tube. H. P. 600 PSI.		100%	-

1.30	0.16	0.20 m - 1.50 m Drilled with HQ double tube, diamond bit and water.					
	2/15 1/15 2/15 0.45	0.31	C.R.=38%					
	0.55	0.47	1.50 m FILL, OC-1, low consistency, high plasticity, moderate to high water content, consists of clay, silt, sand, small pebbles, vegetation roots, some organic material. Color: medium red red brown with red iron oxides.		From 1.50 m to 1.95 m SPT #1 - N=3		23%	-

0.63	C.R.=22%		NOTE: SPT's were taken with a standard 2 in. split spoon & a 140-lbs. safety hammer dropped 30 inches for each blow.		22%	-
		0.78			1.95 m - 2.50 m Pushed and drilled dry with HQ single tube. H. P. 300 PSI.
